# 1 INSPECTION REPORT NATIONAL DAM SAFETY PROGRAM

## BEAVER CREEK RESERVOIR DAM HILL COUNTY, MONTANA MT. - 510

Christian, Spring, Stelbach & Associates  
Bozeman, Montana

February 1981

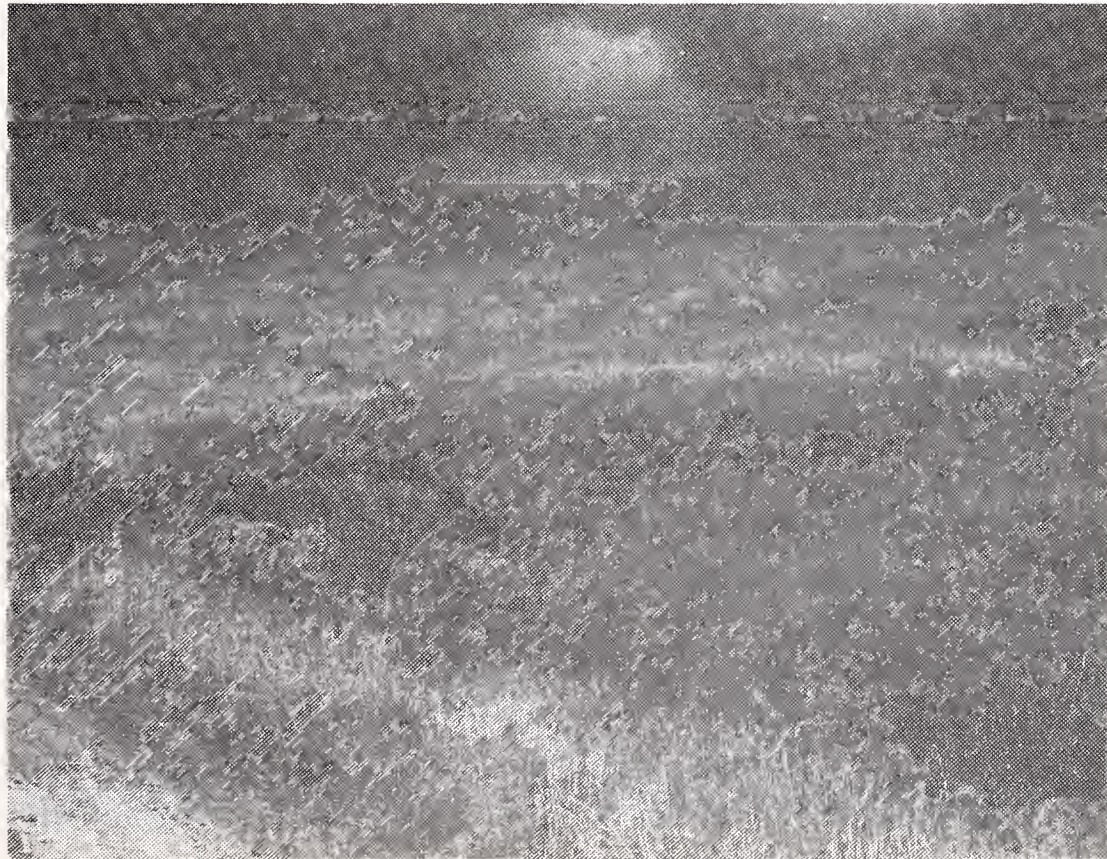
Visual inspection of Beaver Creek Reservoir Dam revealed no visible sign of unusual settlements, cracking, bulging, or depressions which would indicate distress. There is some minor rill erosion on the downstream slope and in the groin area of the right abutment. The downstream slope is well protected with heavy vegetation. Recent photos (May, 1980) show evidence of vehicular traffic on the downstream slope. This practice should be prohibited.

PHOTO 2 - Erosion rill on downstream slope-  
Note dense vegetation.

2. Inspect inside of pressure chamber housing gates, irrigation outlet conduit, and low level outlet conduit and intake. Repair as required.
3. Repair erosion rills on downstream slope and groin area of downstream right abutment by filling, compacting, and seeding or sodding.

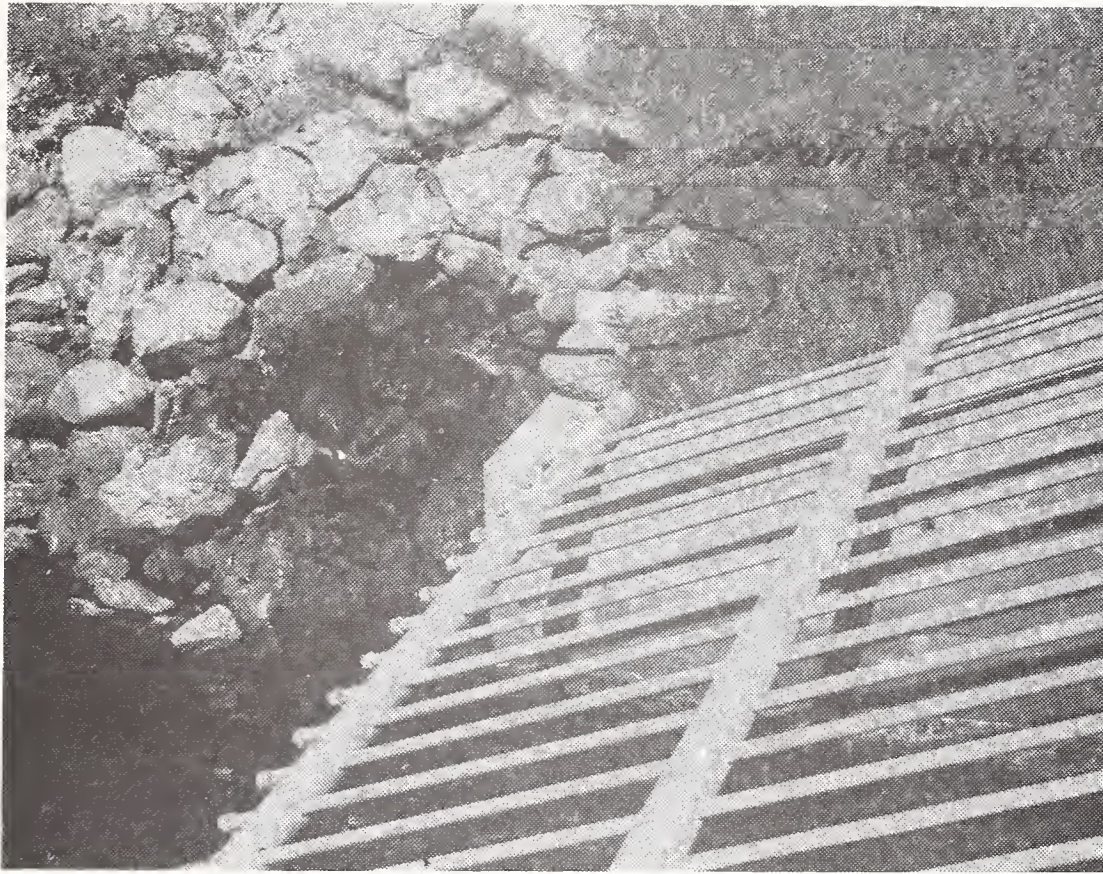
Boring logs indicate that the till has isolated seams of sand and gravel, which was borne out at first filling when a leak developed on the downstream left abutment (Plate 4). A drain system was installed in this area and routed to the irrigation outlet. At the time of our site visit, the estimated flow was 5 gpm (Photo 3). No monitoring of the flow has or is being done. No seepage was noted in the abutment area.

PHOTO 3 - Outlet for drain from  
left abutment

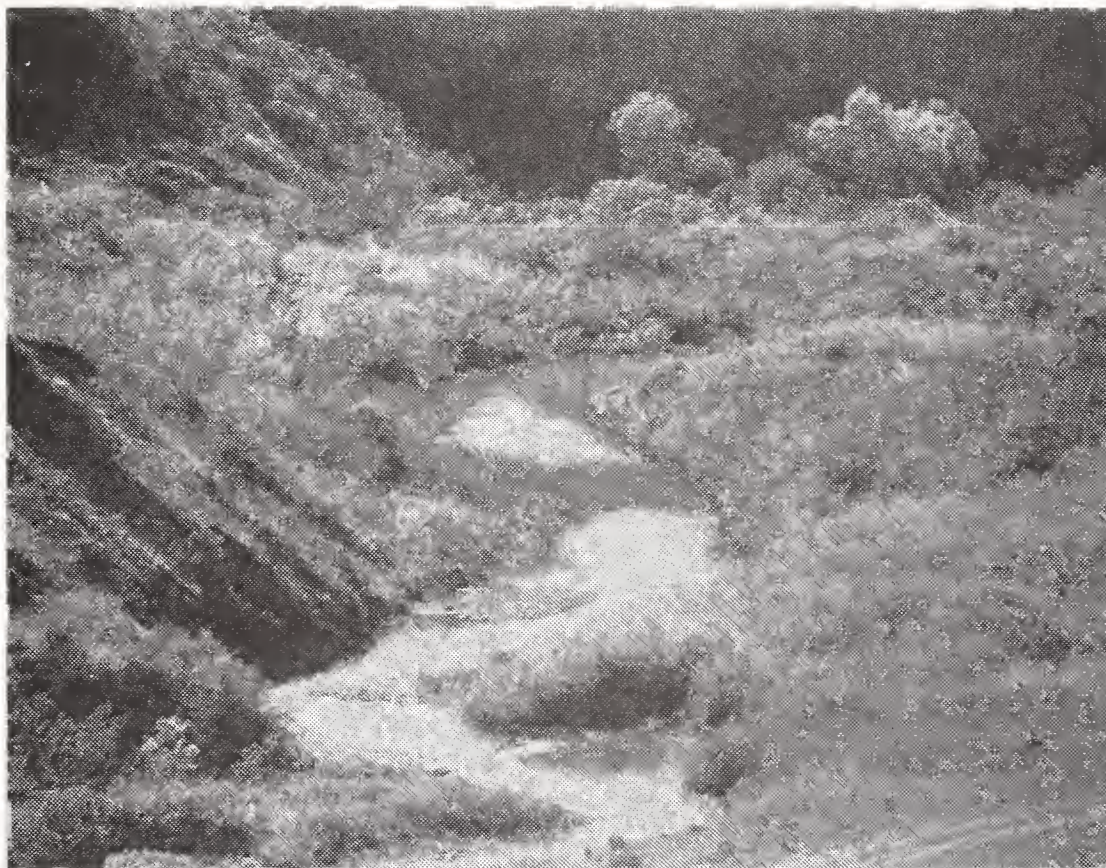
PHOTO 9 - Approximately 600 ft. downstream from spillway outlet. Note meander development

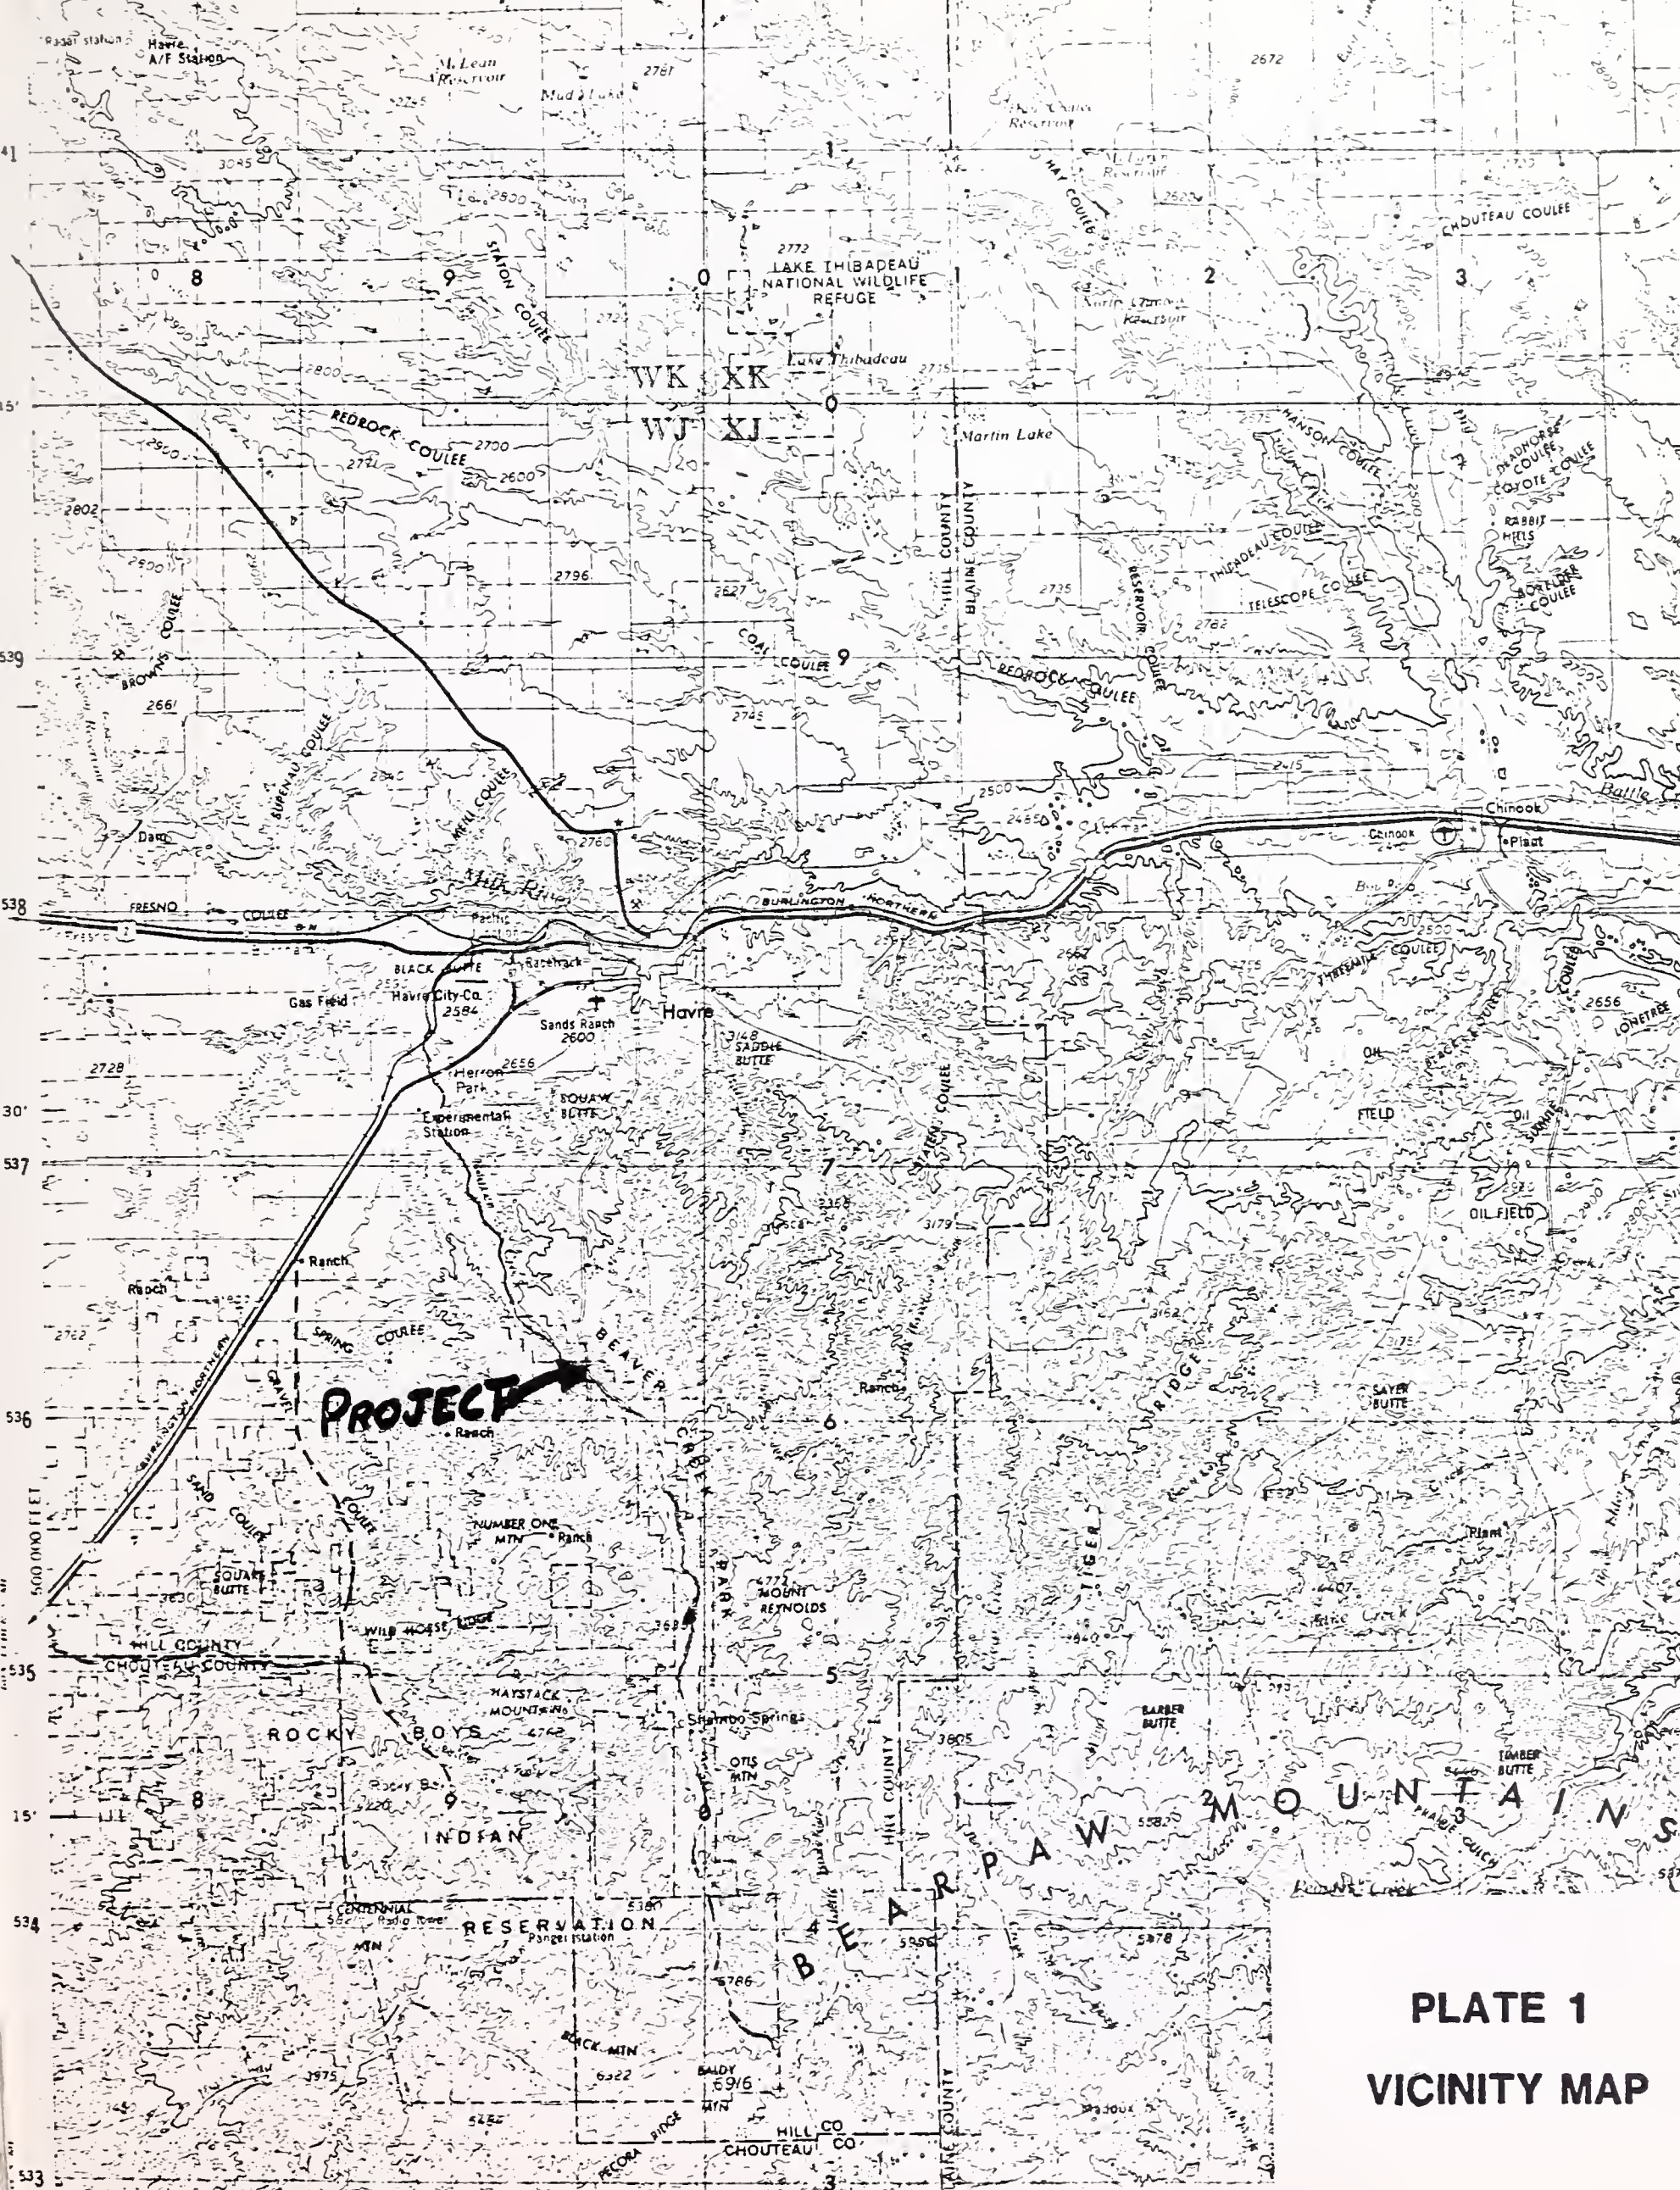
**PLATE 1**  
**VICINITY MAP**

The Beaver Creek drainage (Ref. 2) lies in north central Montana in the southeastern part of Hill County. (Plate 1). The drainage upstream from Beaver Creek Reservoir covers approximately 79 square miles, is approximately 25 miles long, and averages 3.5 miles in width. (Plate 2) Beaver Creek heads in the north central part of the Bearpaw Mountains at an elevation of 6942 feet and flows north to the Milk River about two miles west of the City of Havre at an elevation of about 2480 feet. Elevation of Beaver Creek Reservoir is about 3100 feet. Latitude at center of basin is 48°20' and longitude is 109°40'.
